HAZARDOUS BUILDING MATERIALS INSPECTION REPORT  
61 DURANT TERRACE  
MIDDLETOWN, CONNECTICUT

CITY OF MIDDLETOWN  
245 DEKOVEN DRIVE  
MIDDLETOWN, CONNECTICUT

DECEMBER 7, 2010

EAGLE PROJECT NO. 10-038.13

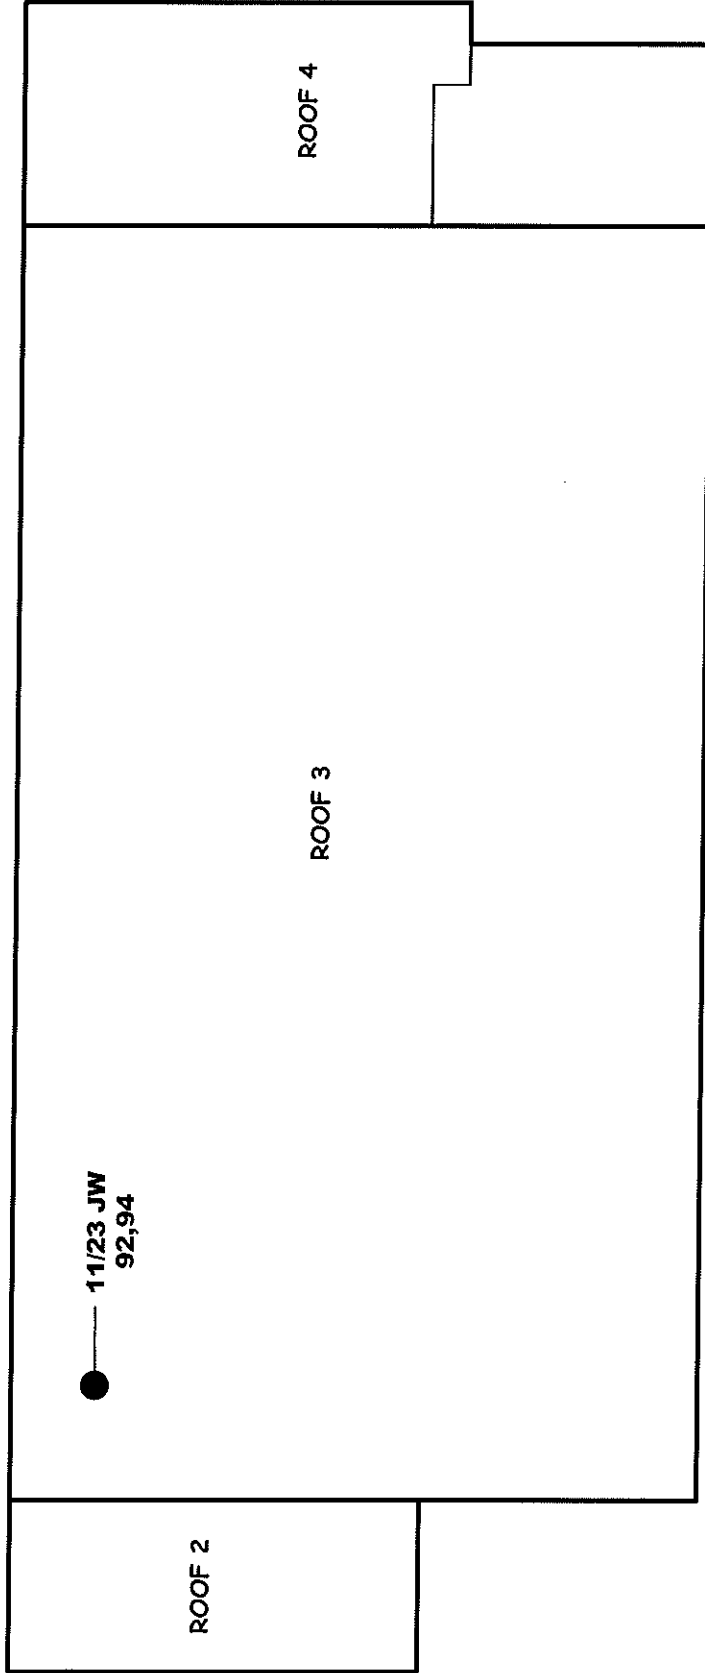
**HAZARDOUS BUILDING MATERIALS INSPECTION**  
**61 DURANT TERRACE, MIDDLETOWN, CONNECTICUT**  
**ROOF PLAN**  
**WITH SAMPLE LOCATION DIAGRAM**

11/23 JW  
91,93
